Idaho Nonpoint Source Program

2003 Field Evaluation Progress Report

Idaho Department of Environmental Quality

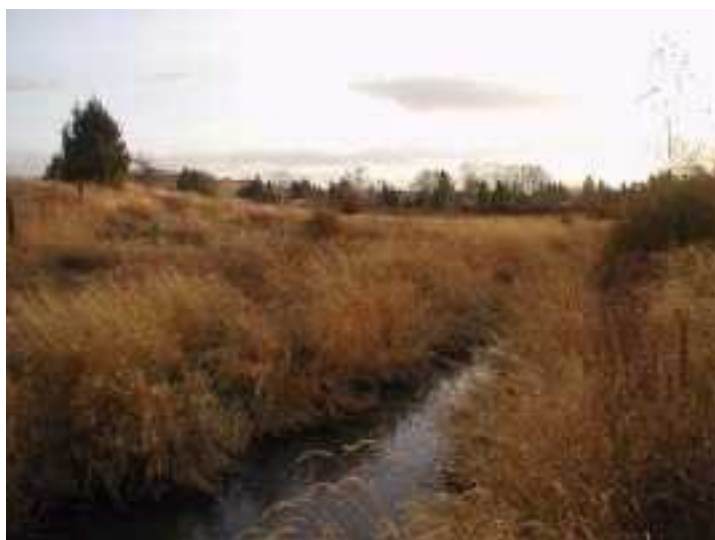
Figure 45: Fosberg area after riparian planting

Description of Completed Activity: Native trees and shrubs were planted adjacent to Paradise Creek to establish a riparian buffer strip (Figure 45). The woody vegetation will shade the stream, control stream bank erosion, and contribute woody debris to the stream system. PCEI also installed protective tubes to prevent animal damage to plants.

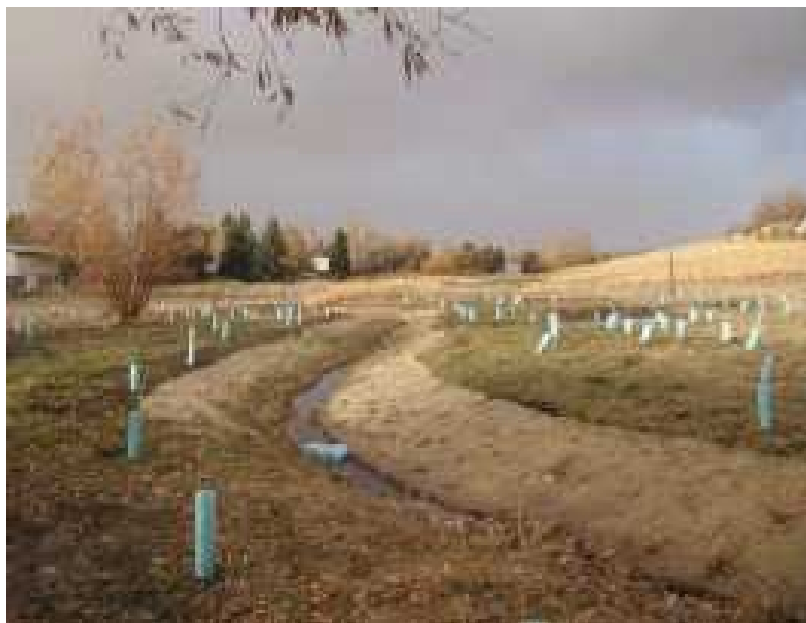
Figure 46: Leffingwell-Reid property after work was complete in Fall 2003

To accomplish these goals, a narrow meandering stream channel and three associated wetlands were constructed. Wetlands vary in depth from 1 to 2.5 feet. Professional Operators Company excavated the site with a track hoe, using an 18-inch toothed bucket. The construction phase took approximately three days to complete. The wetlands are adjacent to the new channel to receive and filter runoff before entering the stream and to increase flood storage capacity (Figure 46).

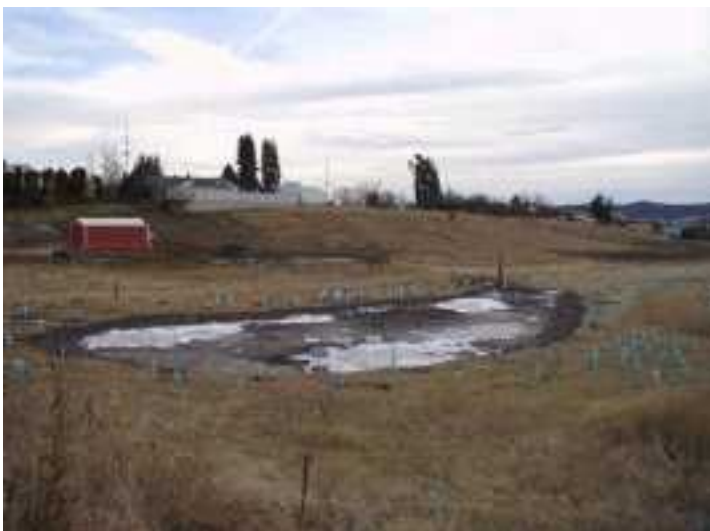
Figure 47: Construction of Lefors Wetland

During September 2002, two shallow wetlands were constructed at the site (Figure 47). The wetlands range from a width of 30 ft to 134 ft and are approximately 140 ft in length with an organic shape. The wetlands' depth ranges from 1 ft to 1-1/2 ft. The wetland design allows the waters of the adjacent stream to enter into the area while providing a defined channel for water movement in low flow situations.

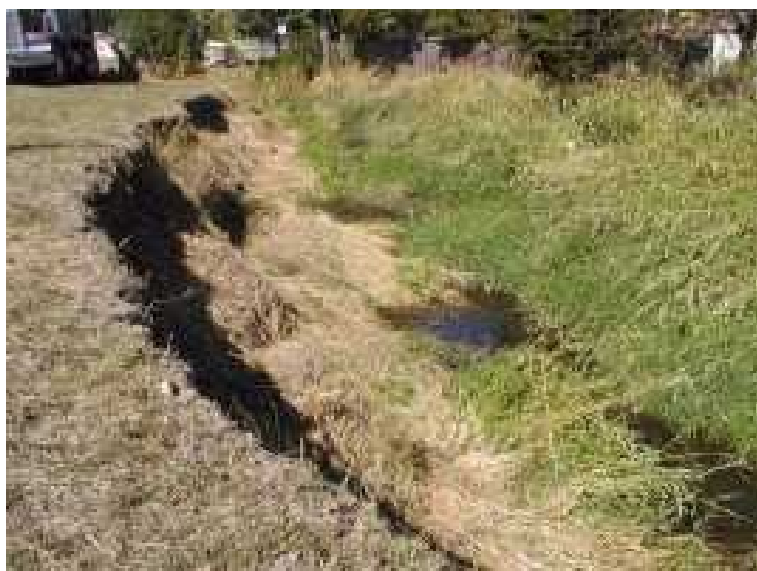
Figure 48: Lightfield Stream bank before work

the past, this reach of Paradise Creek was dredged, which exacerbated the steep banks and promoted incising (Figure 48).

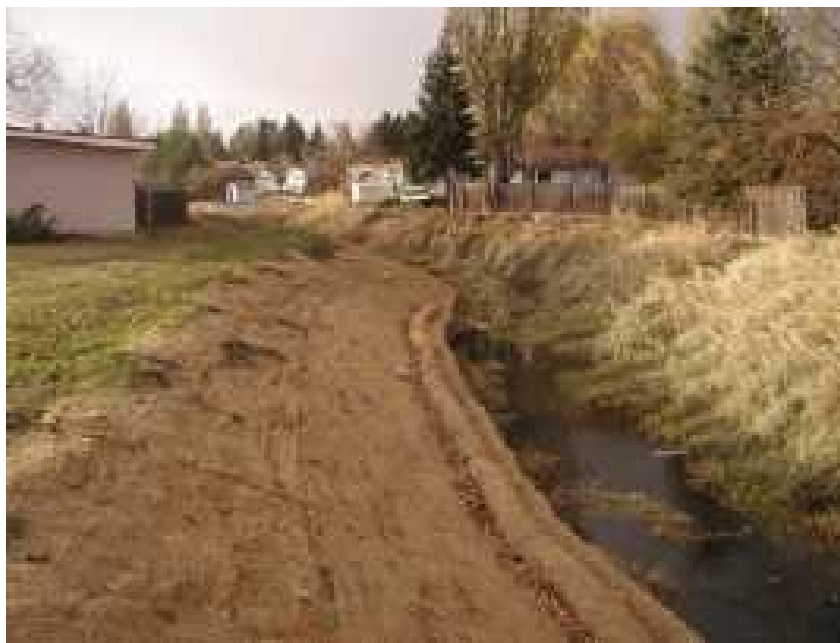
Figure 49: Lightfield Stream bank after work

Description of Completed Activity: The construction phase of the project was completed September 23, 2003. Moscow contractor Dale Stubbs excavated the existing bank to create a 2:1 slope. Slope construction took approximately six hours using a 48-inch toothed bucket. Bio-logs were installed at the toe of slope to provide a shelf for plant material and bank stabilization. The coir logs were terraced two high on the upstream section of the project, this technique used to minimize undercutting in an area of high velocity. The re-sloped bank was promptly seeded with native grasses (tufted hairgrass, ticklegrass, fowl bluegrass, western managrass, prairie junegrass, and Idaho fescue), herbaceous plants (small-fruited bulrush, common rush, creeping spikerush) and native woody species (red-osier dogwood, sandbar and Mackenzie willow [plugs], quaking aspen, Douglas hawthorn, Nootka rose, serviceberry, shiny leaf spirea, and syringa) (Figure 49).

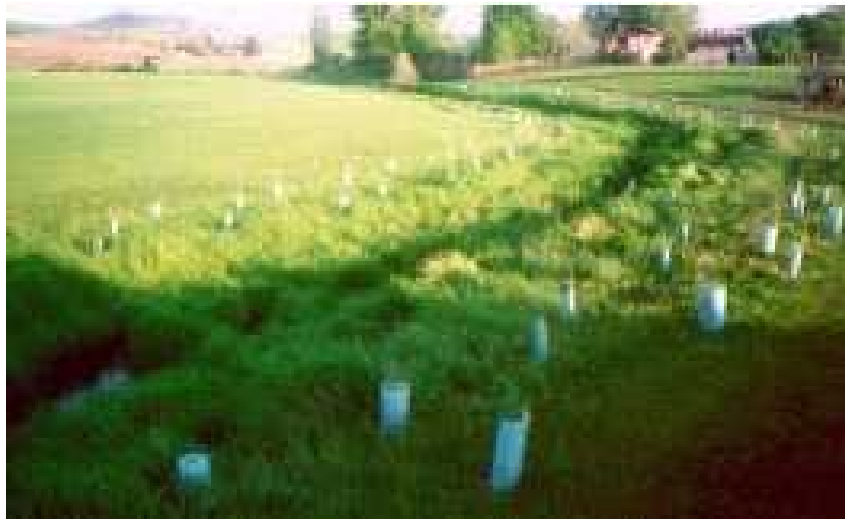
Figure 50: Mountain View Park plantings

Description of Completed Activity: Beginning in 1999, a variety of volunteer groups helped plant 1,100 trees and shrubs along the tops of the stream banks. In spring 2000, 600 plants were planted and in the fall an additional 500 plants were planted at this site. All plantings have protective tubes installed around them (Figure 50). These plantings will eventually create a riparian forest buffer along the creek, shading the stream, filtering runoff, and enhancing wildlife habitat and aesthetics. In 2001, PCEI staff and volunteers replanted vegetation in areas of low survival and performed maintenance of previous plantings, including weeding, tube removal and watering. The Mountain View Park site was also the headquarters of the Annual Paradise Creek Clean-Up.

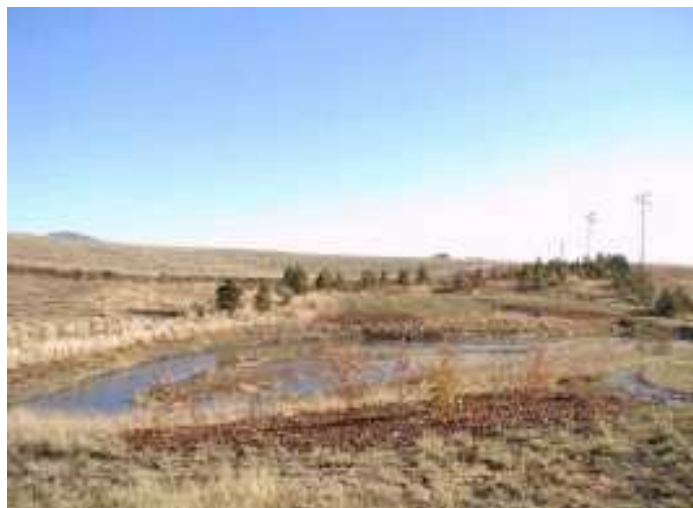
Figure 51: Orchard Wetland

Description of Completed Activity: The purpose of the Orchard Wetland project was to create a wetland to filter the nutrients and sediment from the farm fields and from adjacent livestock areas. Approximately 1000 cubic yards of soil were excavated from this site and moved to another location on the site to create a terrace. The newly constructed wetland has a 4-5 foot bottom with a higher 3 ft excavation in the center of the wetland that fulfills the “shallow excavation” criteria of the 319 NPS grant. The

wetland area was planted with woody vegetation as well as wetland vegetation to help improve water quality by reducing nutrients through the water-filtering qualities of wetland plants. The banks of the wetland area were secured with geotextile fabric and were seeded with native grasses. In the spring of 2002, willow poles and red osier dogwoods were planted along the banks to secure the banks and introduce shade to the system. Additional native plantings were planted in the spring of 2002 (Figure 51).

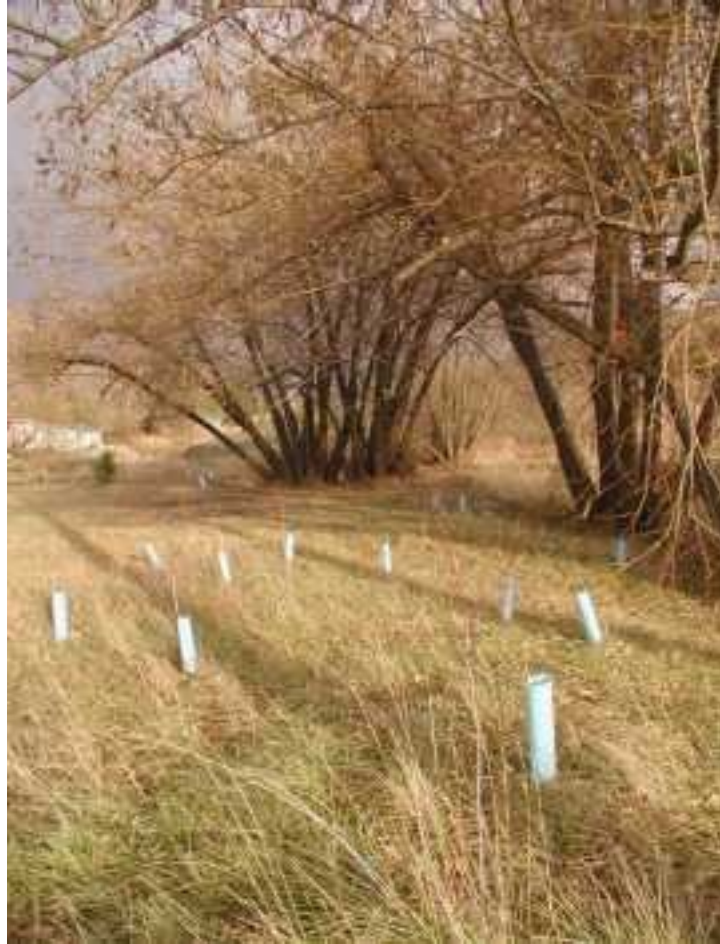
Figure 52: Renaissance Charter School riparian planting

Previous Conditions: The stream segment had nearly vertical, slumping, eroding stream banks that were frequently undercut by high water events, contributing sediment to the creek. The majority of the stream bank soil was exposed, except for a few patches of reed canary grass. Where Paradise Creek flowed by the school, it was lined by golden willows, a non-native willow species that discourages a diversity of riparian trees and shrubs and threatens power lines above.

Description of Completed Activity: Willow poles and other native riparian plant species were planted along the stream banks and on the floodplain (Figure 52). These native shrubs will help stabilize the failing stream banks, shade the stream, and introduce woody material to the stream system. Charter school students helped with the planting, and ongoing plant maintenance. In addition, students worked with PCEI staff to install log habitat structures.

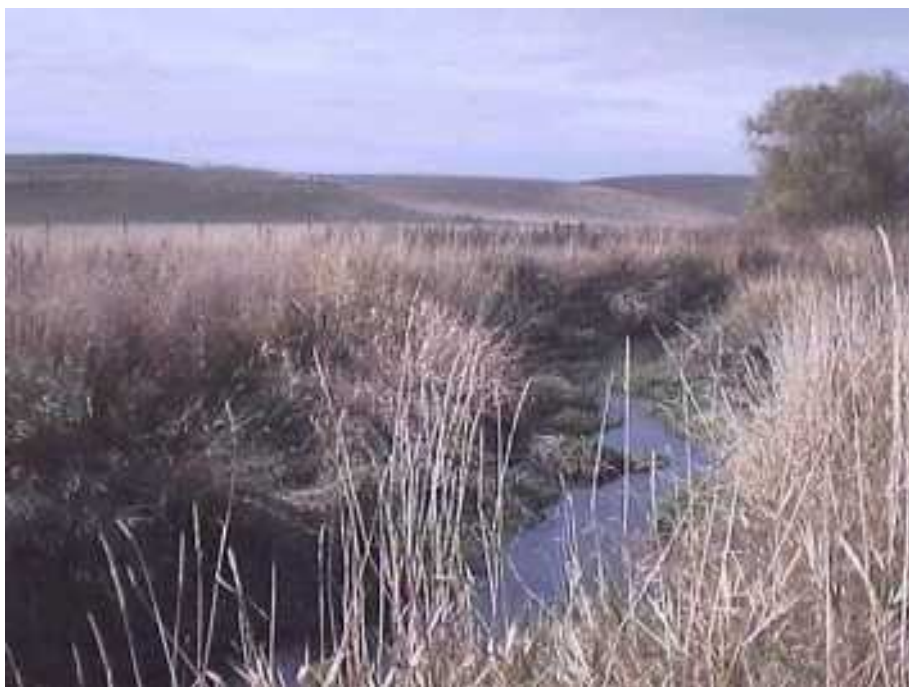
Figure 53: State Line stream bank stabilization and riparian Planting

Previous Conditions: Stream banks along this segment of Paradise Creek were eroding due to a lack of woody vegetation and the steepness of the banks. Reed canary grass formed a dense monoculture whose shallow root mats promoted slumping of the stream bank. Thus, the stream banks were frequently undercut during heavy storm events. Moreover, the lack of trees or woody vegetation along this stream segment also allowed solar radiation to heat the stream water, which decreases dissolved oxygen and is damaging to aquatic wildlife.

All the soil and material that was excavated to recontour the stream banks was moved off site. Where feasible, concrete was removed from the stream channel. The removal of concrete will allow vegetation to be planted along the stream to provide habitat for fish and wildlife. In selected areas, coconut fiber-filled BioLogs®, pre-planted with wetland plants, were installed along the toe of the stream bank to stabilize the bank and to help improve water quality through the water-filtering qualities of wetland plants.

Willow (*Salix exigua*, *Salix Drummondia*, *Salix mackenziana*) and red-osier dogwood (*Cornus stolonifera*) poles and dogwood fascines were planted on the stream banks where the initial vegetation did not establish well. Through time, the poles will provide a dense network of interconnected roots to hold the bank in place and catch sediment and organic matter to facilitate the establishment of other vegetation (Figure 53).

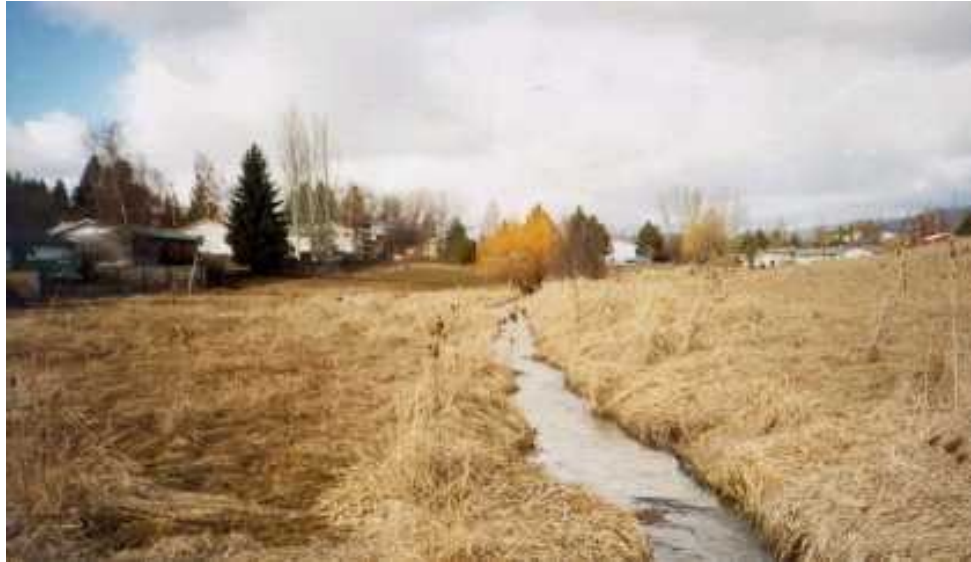
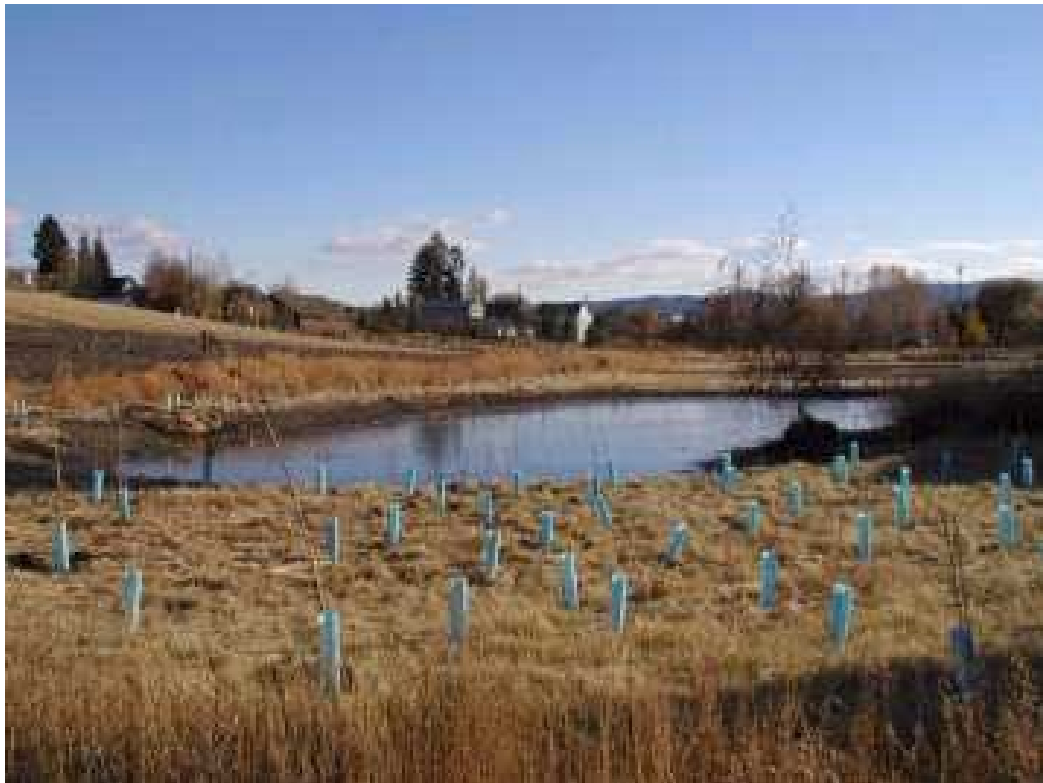
Previous Conditions: The site is on a tributary to Paradise Creek in a draw. The stream segment was bordered by a steep bank on the east side and a wide, flat wet area to the west. The site was inundated for a significant portion of the year, which made it a suitable location for a wetland. Reed canary grass was the dominant vegetation along the stream segment, and few trees or other woody species were present. The site was directly downstream from a horse pasture and was impacted by associated pollutants entering the water from upstream.

Figure 54: Streets site before planting

Figure 55: Streets site after planting

Wetlands were constructed on the tributary to Paradise Creek to improve flood control, provide native habitat for wildlife, and filter pollutants. The constructed wetland also provides recreational and educational opportunities for the community. Native species of woody shrubs, trees and grasses were planted along the bank to provide shade to the stream and wetlands and wildlife habitat. Herbaceous wetland plants were planted in the wetland to help improve water quality by reducing nutrient loading through filtering. All plantings are protected from animal damage with plastic tubes.

Native willow and cottonwood cuttings were planted along the banks of the stream to secure the banks and introduce shade to the system, creating a woody riparian buffer. Woody riparian buffers offer many benefits, including filtration of runoff, wildlife habitat and flood water retention. PCEI also organized a day of camas planting with students from Renaissance Charter School and Lapwai Elementary School. The students learned about the ecological and cultural significance of the camas from a member of the Nez Perce Tribe and helped restore the plant to its native Palouse Prairie (Figure 54 and Figure 55).

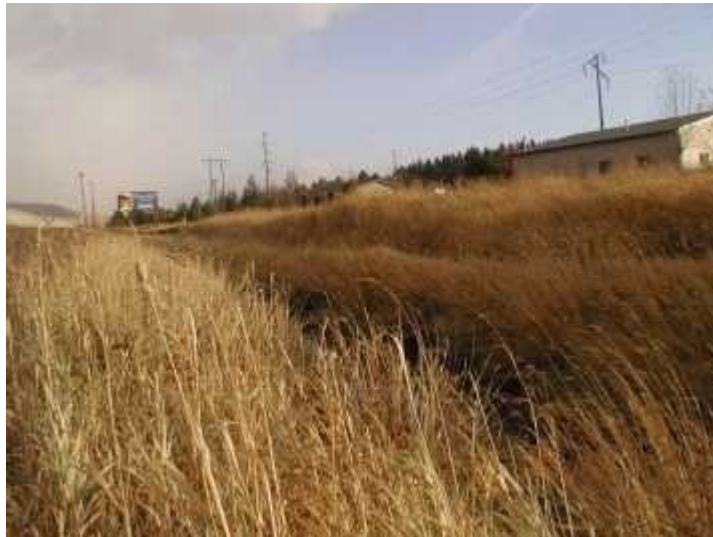
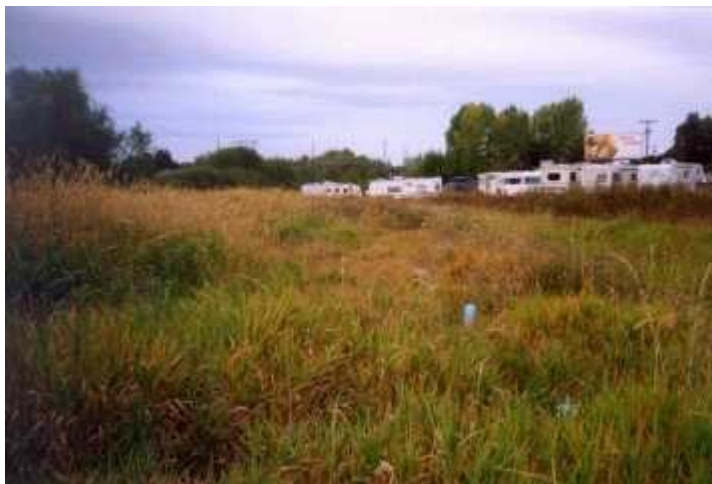
Previous Conditions: This stream reach had been routinely dredged by the City of Moscow, and the dredge spoils had been dumped on the stream bank. Consequently, the stream channel is excessively wide and uniform, with steep, very high banks. Reed canary grass, Canada thistle, and prickly lettuce were the only vegetation on the stream banks.

Figure 56: Styner riparian area before planting

Figure 57: Styner riparian area after planting

Description of Completed Activity: Willow poles were planted along the stream bank for erosion control and to provide shade to lower water temperatures. Native shrubs, such as snowberry, aspen, serviceberry, and ponderosa pine, were planted to establish a riparian buffer. Girl Scouts and elementary school students participated in the planting (Figure 56 and Figure 57).

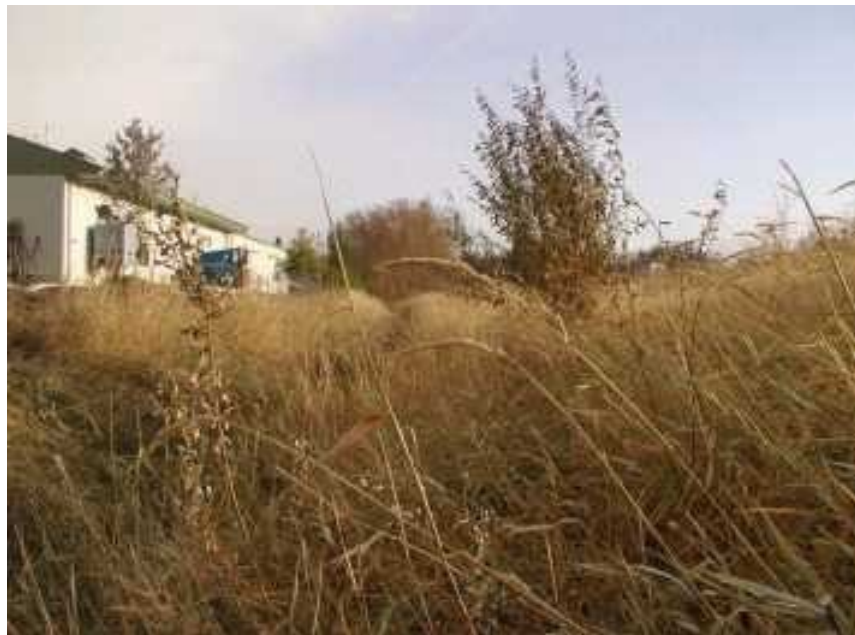
Figure 58: Sweet Avenue riparian planting

Previous Conditions: This section of Paradise Creek had been channelized and straightened. Eroding banks rose steeply on both sides. Lack of vegetative cover allowed solar radiation to warm the stream. These conditions presented minimal habitat value for wildlife. Furthermore, a parking lot was scheduled for construction adjacent to the stream, and this restoration project provided opportunities to create bio-filtration systems for the future parking lot runoff. The floodplain had been occupied by a concrete batch plant and by a pesticide and diesel storage facility. Hazardous waste cleanup was conducted by the State of Idaho.

Description of Completed Activity: PCEI constructed channel meanders, a narrower low-flow channel, and a more functional floodplain. The meanders provide increased surface area for infiltration and reduced water velocity, and the constructed low-flow channel, sized for 2-year flows, benefits the aquatic biota. (The riparian floodplain was built to contain a 500-year event and provide water storage during storm events.)

Water quality is improved as suspended sediment and associated pollutants settle out on the floodplain during flood events. Hydrologic modeling showed that the constructed two-stage flood channel would not cause a rise in 100-year flood elevations. In fact, the modeling showed a drop in localized flood elevations of up to 1.5 feet.

This project included a baseline- and effectiveness-monitoring component that documented biological, chemical, and physical components of Paradise Creek at the Sweet Avenue reach and other sites within the City of Moscow for comparison. Bioaccumulation data was also collected, which may provide valuable information for restoring coldwater biota and salmonids in the Paradise Creek Watershed (Figure 58).

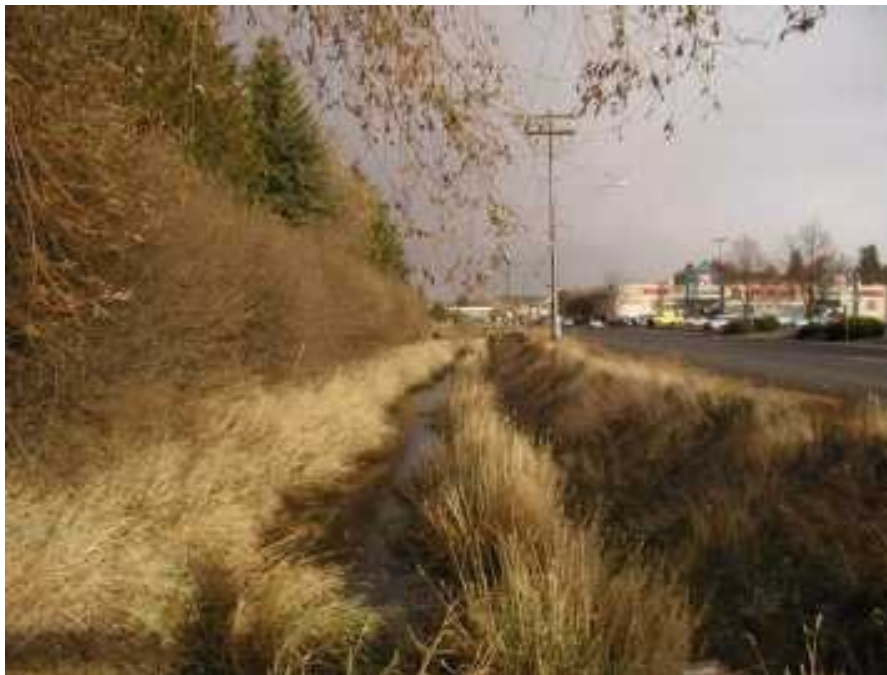
Figure 59: Moscow wastewater treatment wetlands planting

Previous Conditions: The stream segment had near vertical, slumping, eroding stream banks with little vegetation that contributed to the sediment load in the creek. Paradise Creek had been dredged in this reach many different times, which added to its degraded state. In the past, the City of Moscow dumped asphalt onto the sides of the bank in an effort to stabilize the side.

Description of Completed Activity: The purpose of this project was to reslope the stream bank to a 2:1 or 3:1 slope from its near-vertical state reduce erosion, and allow for the establishment of woody vegetation. The project site is 358 linear feet of a heavily damaged, ditch-like creek. The stream bank is composed almost entirely of fill, especially gravel and concrete chunks. After removal of the debris, the site was hydroseeded with a native seed mix and then covered with erosion control fabric. Snowberry and Wood's rose were planted on the site. A few sedges and rushes were planted at the toe of the slope (Figure 59).

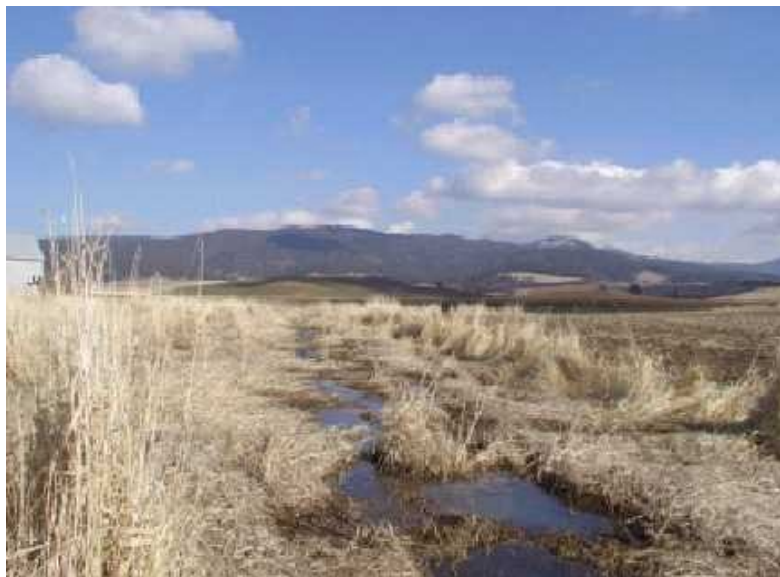
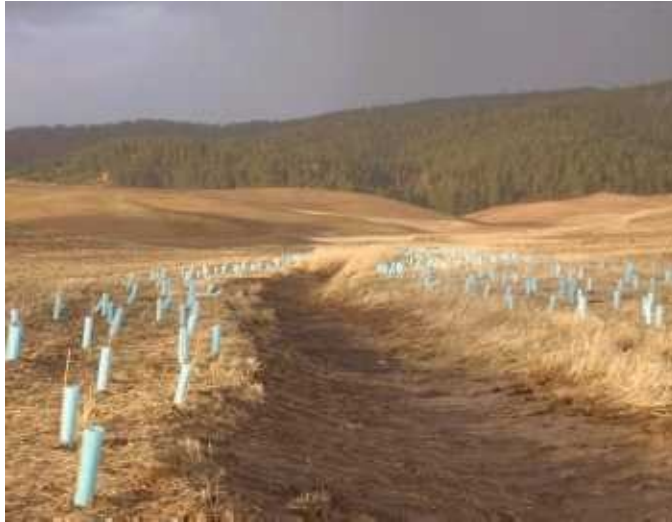
Previous Conditions: Reed canary grass lined the banks of the two Paradise Creek tributaries flowing through the Brockington property. Active wheat fields were directly adjacent to the stream. A riparian buffer was absent in this section of the creek, which exposed the creek to direct solar radiation as well as runoff containing sediments, nutrients, and pesticides. There were multiple equipment crossings through the eastern tributary.

Figure 61: Brockington Riparian Area prior to planting woody vegetation

Figure 62: Brockington Riparian Area immediately after woody vegetation was planted. Farm equipment will be restricted to designated waterway crossings. Plastic collars protect young plants from deer and elk until plants become established.

Description of Completed Activity: The scope of this project was to plant a variable width buffer along the two tributaries on this property, including a total length of 2,500 feet. The riparian buffer ranges from 10 to 40 feet in width and consists of native shrubs and trees. The buffer area of the eastern tributary was also seeded with native grass seed. PCEI completed minimal excavation along the eastern tributary to create a narrow, low flow channel with associated floodplain, in conjunction with the adjacent Townsend project. In addition to the excavation coordinated by PCEI (the current agricultural operator), Larry McMillan contributed by excavating the sediment-laden channels of both tributaries. McMillan's work included excavating to the level of the culvert below the Brockington driveway. The Brockington project borders the Big Draw project to the north and the Townsend project to the east and south, therefore it is expected to have significant benefit as a wildlife corridor as vegetation matures (Figure 61 and Figure 62).

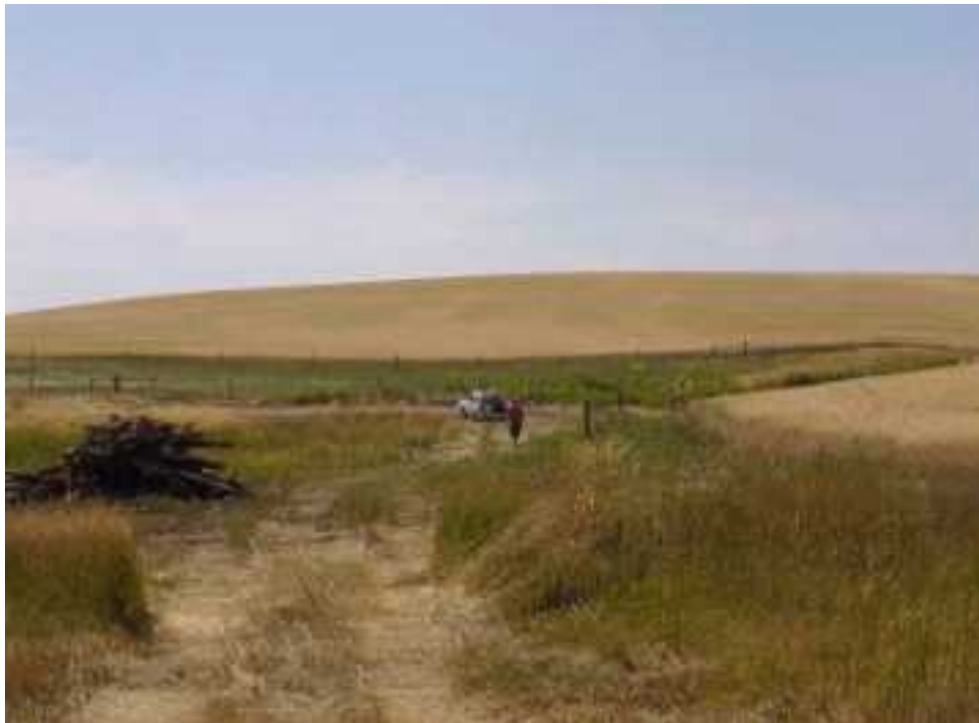
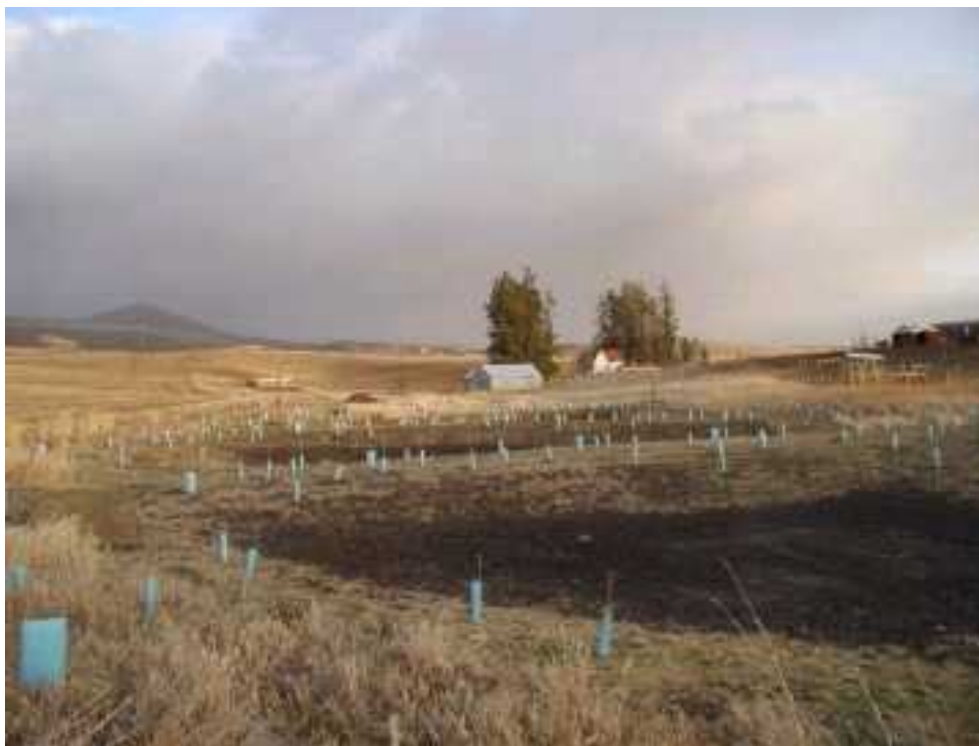
Previous Conditions: This seasonally wet draw with intermittent springs collects a significant amount of water from the surrounding hills and is a tributary to Paradise Creek in the spring. In the past, this draw has been utilized as horse pasture. The Forbes family recently purchased the property and decided to enhance its value as native habitat and improve its water quality. Prior to restoration, reed canary grass, meadow foxtail, morning glory, and other invasive weeds dominated ground cover. There was little vegetative diversity at this site.

Figure 63: Forbes area in Spring 2003, prior to wetland construction and riparian planting

Figure 64: Forbes area after Fall 2003, including wetlands and woody riparian plants

All exposed soil was seeded and mulched after construction. Species used were fowl bluegrass, tufted hairgrass, ticklegrass, prairie junegrass, and yarrow. Native woody and herbaceous vegetation was planted in the fall of 2003. Herbaceous plants will continue to be planted over the next few years as the storage capacity and other characteristics of the wetlands become more apparent. PCEI organized a planting of 150 camas bulbs in October 2003 with students from Lapwai Elementary School. The students learned about

the cultural and ecological significance of camas in addition to helping restore the species (Figure 63 and Figure 64).

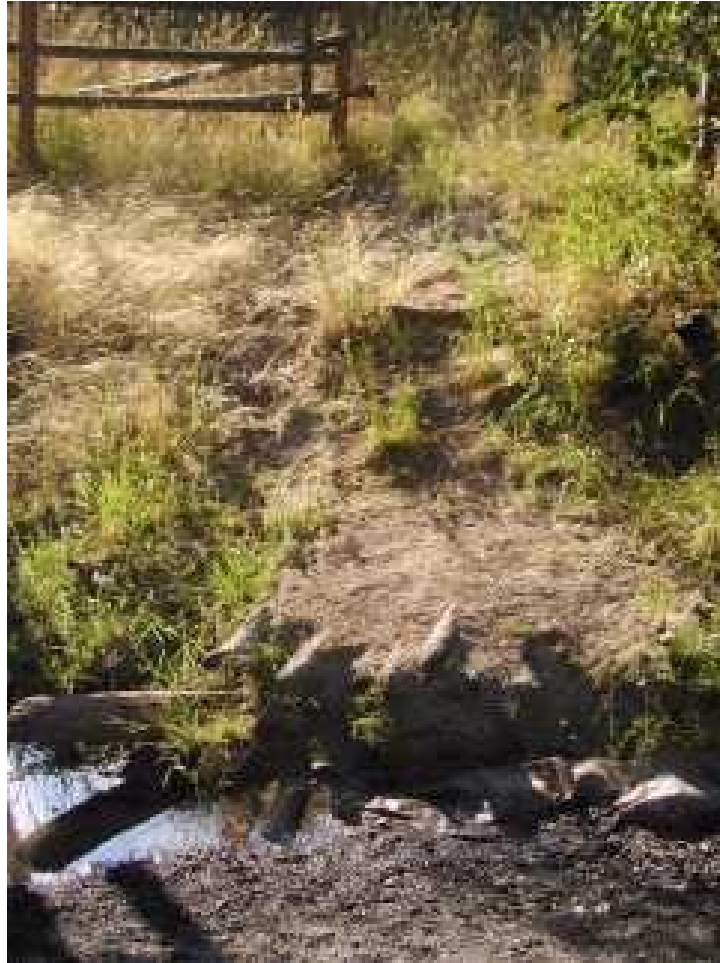
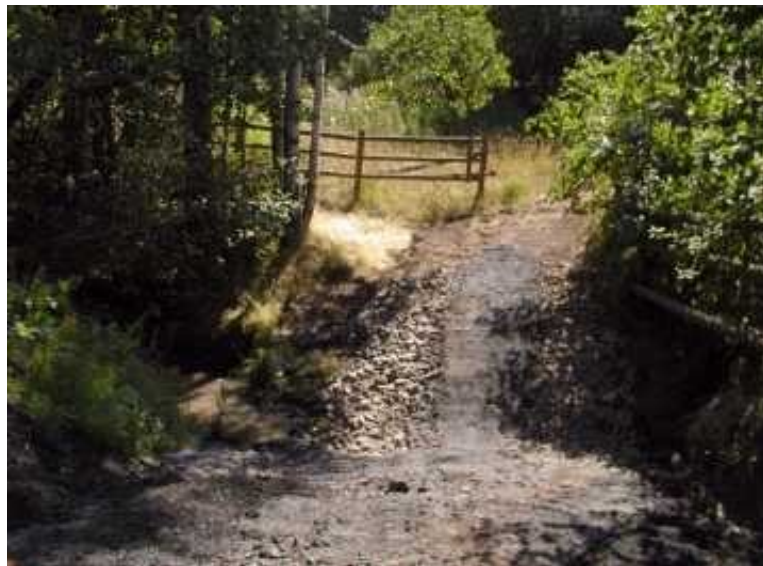
Previous Conditions: This section of Paradise Creek, located three miles north of Moscow, has populations of quaking aspen, Douglas hawthorn, snowberry, serviceberry, cow parsnip, and many other species that compose a healthy riparian buffer. Restoration effort targeted a specific problem area disturbed by an established horse crossing that provided access to pasture on both sides of the creek. Prior to restoration, continuous use of the stream section for animal passage contributed to nutrient and sediment inputs. The presence of large stands of Canada thistle in proximity to the creek was also of concern.

Figure 65: Garton Stream before the work

Figure 66: Garton Stream after the work

- Improved water quality through construction of a hardened rock crossing that limits creek disturbance while still providing access to pasture.
- Minimized erosion from animal impact by concentrating the animal traffic to an area properly constructed to withstand animal use.

Mark Hawley of Moscow was hired to do shallow excavation and to place the rock fill. Rock, eight inches or less in diameter, was used to fill the depression, and a two foot strip of gravel dressing was placed down the middle of the crossing to lessen the possibility of injury to the animals. Filter fabric was installed beneath the rock. Project construction lasted about five hours. Figure 65 and Figure 66 show the crossing before and after the work was accomplished.

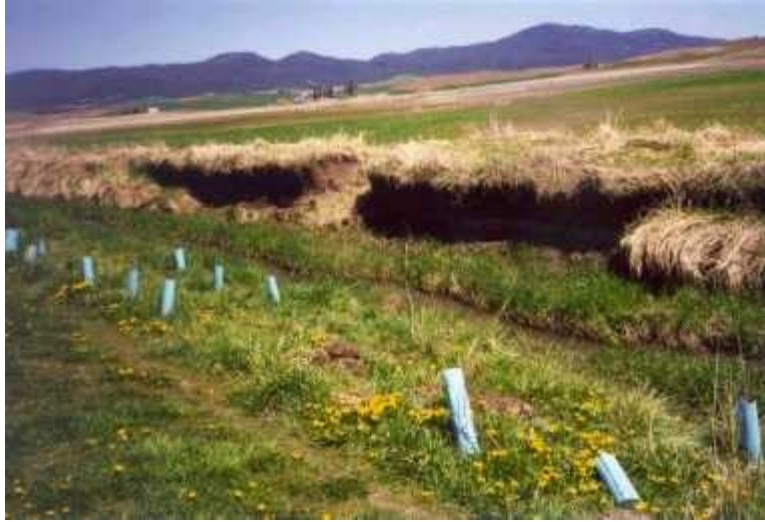
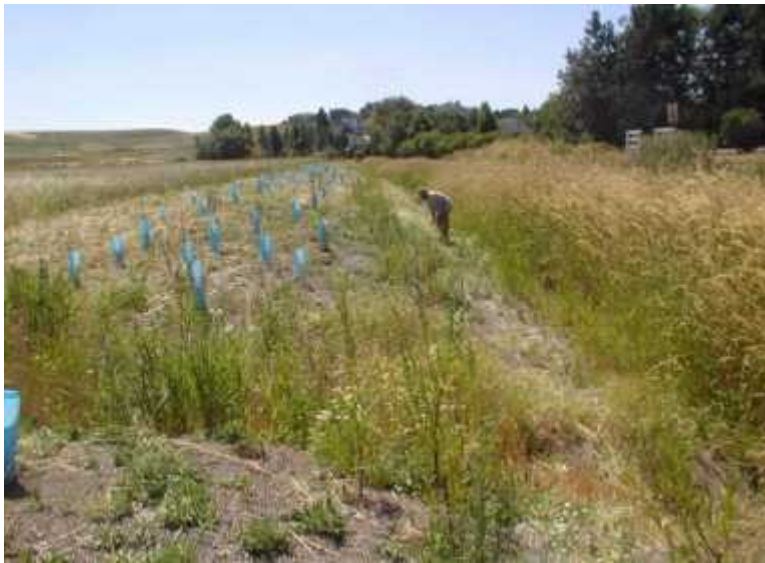
Previous Conditions: These stream segments had slumping, eroding stream banks that were frequently undercut during heavy storm events, contributing sediment to Paradise Creek. In addition, annual dredging artificially widened and incised the stream channel. Widening of the stream and the lack of shading caused the water to heat up during low flow periods of the year. Lack of a riparian buffer allowed direct flow of agricultural runoff into the creek. Reed canary grass was the dominant cover type. Canopy cover and wildlife habitat were minimal along this segment of the creek.

Figure 67 shows the near vertical bank cut before the work was completed and Figure 68 shows the bank after work was completed.

Figure 67: Hall and Mountain View Gully before work

Figure 68: Hall and Mountain View Gully after work

Description of Completed Activity: PCEI resloped approximately 740 linear feet of the heavily damaged, ditch-like creek to a low-flow channel with a terraced floodplain. Approximately 1,568 cubic yards of soil was excavated from this site, and the excavated soil was spread on the Hall property. The newly constructed low-flow channel has a bottom width of 3 to 4 feet, compared to the old channel-width of 10 feet. The overall shape of the channel is a “V”.

Woody riparian buffers offer many benefits, including filtration of runoff, wildlife habitat, soil stabilization, sediment trapping, and floodwater retention. These plantings will be protected from vole damage with plastic tubes. The plants were weeded and watered during the summer of 2003 by AmeriCorps*NCCC members.

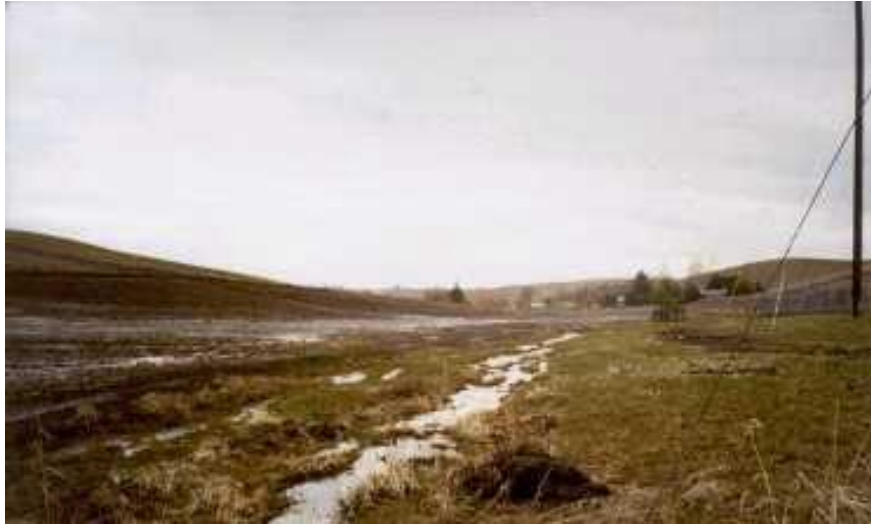
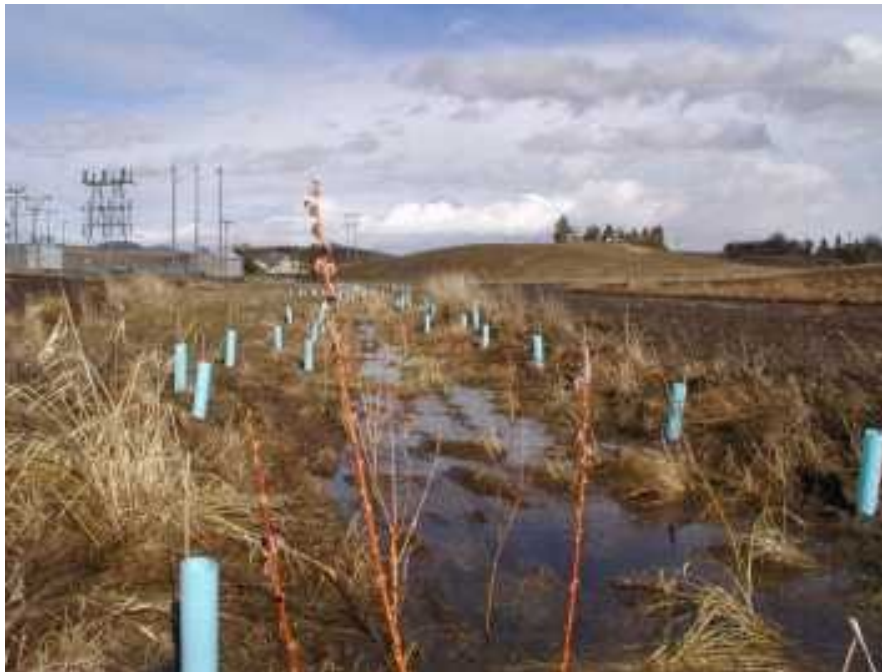
Previous Conditions: Prior to restoration, the channel of this tributary to Paradise Creek had been straightened to allow for cultivation to the stream's edge. Reed canary grass lined the banks of the creek, and active wheat fields were directly adjacent to the stream on the east side (Figure 69). A riparian buffer was absent in this section of the creek, which exposed the creek to direct solar radiation as well as agricultural runoff containing sediments, nutrients, and pesticides.

Figure 69: Harden Riparian Area prior to work

Figure 70: Harden Riparian Area after work completed

Description of Completed Activity: The purpose of this project was to create a riparian buffer along an 860-foot reach of a tributary to Paradise Creek, so 563 trees and shrubs were installed along the stream channel. Woody riparian buffers offer many benefits, including filtration of runoff, soil stabilization, wildlife habitat, and floodwater retention. These plantings will be protected from vole damage with plastic tubes. The plants in Figure 70 were watered and weeded on multiple occasions in 2003.

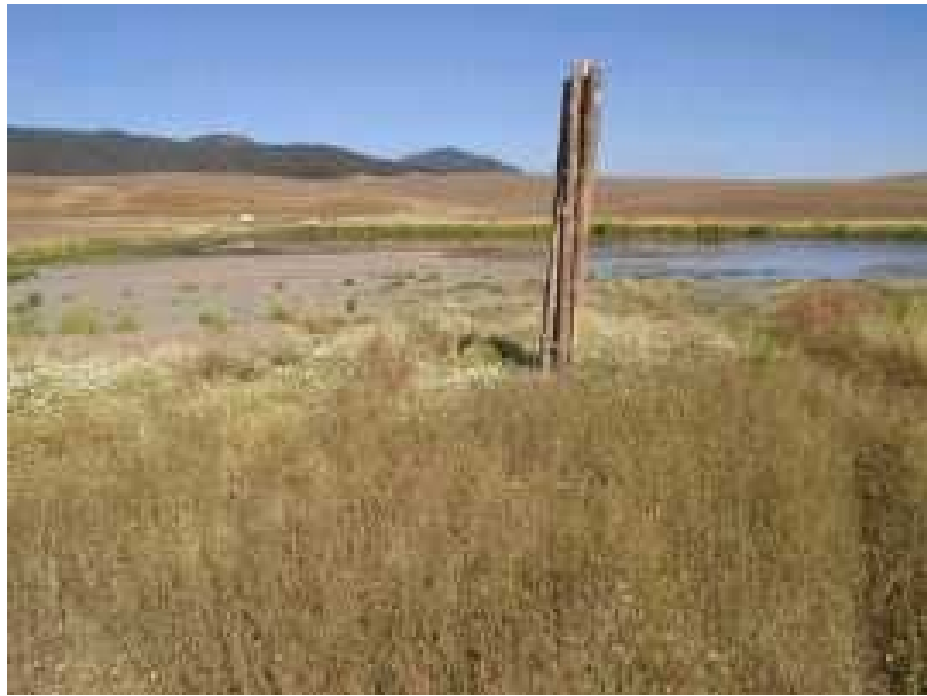
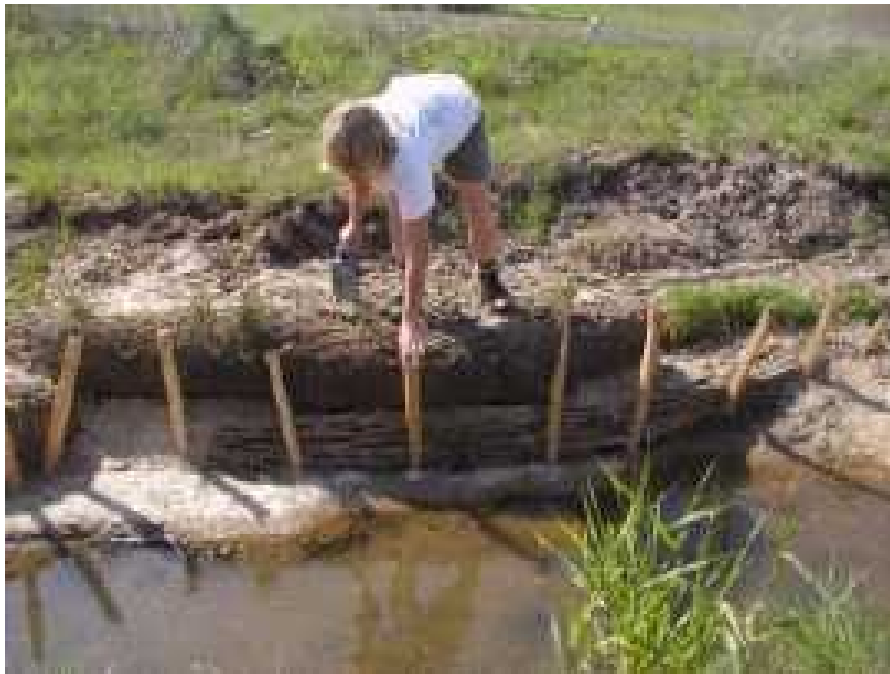
Previous Conditions: Prior to restoration, the stream channel was straightened and acted as a drainage ditch along Foothill Road. Reed canary grass lined the banks of the creek, and active wheat fields were directly adjacent to the stream. A riparian buffer was absent in this section of the creek, which exposed the creek to direct solar radiation as well as storm water runoff containing sediments, nutrients, and pesticides.

Figure 71: Predator bird habitat structure Summer 2003

Figure 72: Stream bank stabilization being installed Summer 2003

Subsequent work was completed during Spring 2002 and Spring 2003, including 1,790 feet of stream bank restoration. Due to difficult growing conditions, including hard clay soils and vole damage, vegetation failed to establish along some sections of the stream. In the spring of 2002, quaking aspen and red osier dogwood plugs from the National Tree Trust were planted around the wetlands and in other un-vegetated areas.

In the spring of 2003, willow and cottonwood poles, and red osier dogwood plugs were planted on the stream banks in spots lacking woody vegetation. Fascines were constructed from live cottonwood and willow cuttings and were placed where banks were bare and sloughing into the creek during high flows. Native wetland plugs, including small-fruited bulrush, Nebraska sedge, and Baltic rush were planted along bare sections of the streams. These deep-rooted plants will hold the stream bank in place and filter sediment and nutrients from the stream. Ponderosa pines from the National Tree Trust were also planted adjacent to the stream to provide long-term shade, contribute woody

material to the stream system, and provide wildlife habitat. All work was done with the help of AmeriCorps*NCCC teams (Figure 71 and Figure 72).

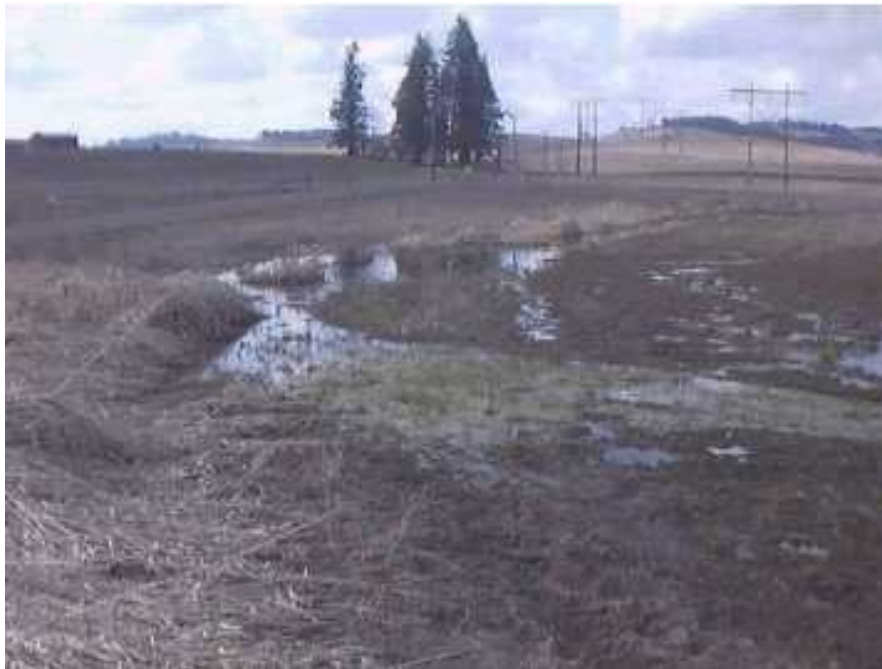
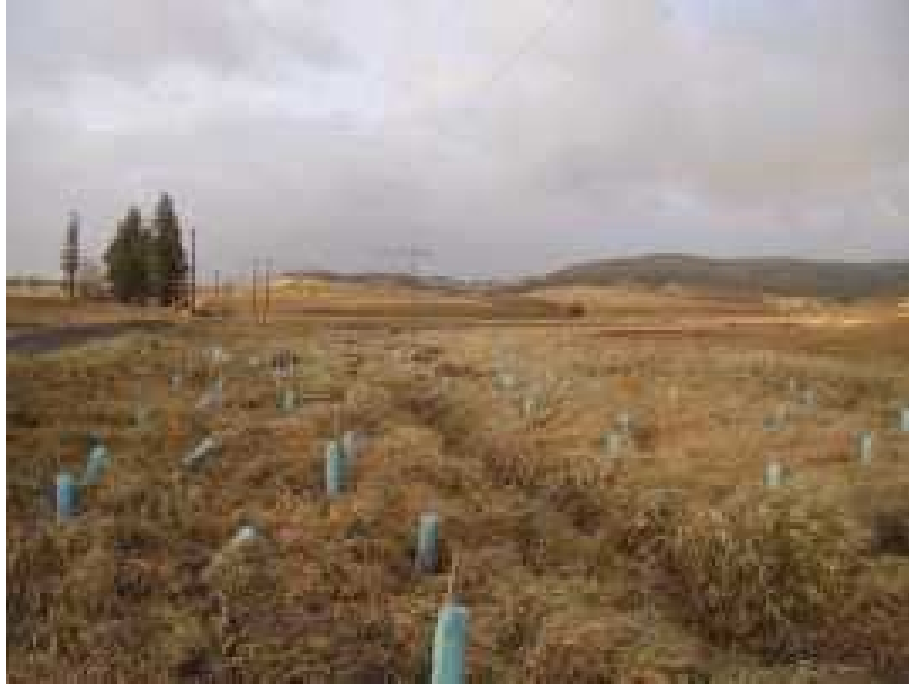
Previous Conditions: Prior to restoration, the stream channel was nearly straight and was largely overgrown by reed canary grass. There was no native vegetation present other than a few native wetland plants. The reed canary grass monoculture provided little shade to the stream and little wildlife habitat. The lack of woody vegetation and prevalence of fine silt in this section of stream encouraged the development of an excessively wide, shallow channel. In addition, downstream landowners were concerned about flooding resulting from the channel silting in.

Figure 73: Morton extension area prior to work

Figure 74: Morton extension. Area after work completed

Description of Completed Activity: A new “E” type stream channel, approximately 1’ wide and 10” deep was dug with a trackhoe. Channel sinuosity was increased by the inclusion of numerous meanders in the newly constructed channel, doubling the channel length within this reach. An increase in sinuosity will encourage more natural sediment deposition, develop stream-associated wetlands, and reduce stream velocity and thus erosive force.

Native riparian shrubs were planted after channel construction. A riparian buffer of woody vegetation will shade the stream, reduce water temperatures, stabilize soil, filter runoff from adjacent roads and farm fields, and contribute woody material to the stream system (Figure 73 and Figure 74).
